Manhole Inspection Summary

Manhole # S23GG1023MH

Insp Date: **12/13/06 9:12 AM**

Location Address: **1331 41ST ST**

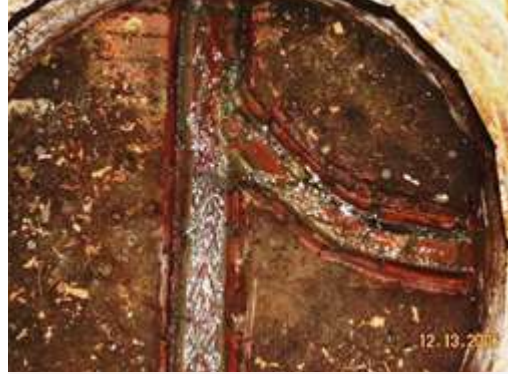
Top View

Evidence of surcharge - Bench debris.

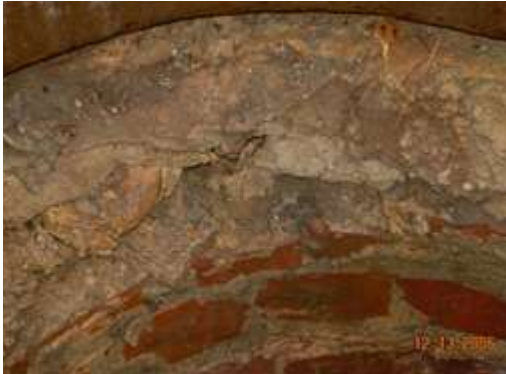
Defect

Frame leaks. Adjustment deterioration and infiltration.

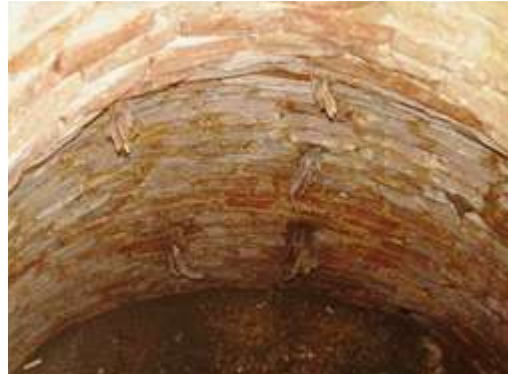
Defect

Corbel and Barrel infiltration. Corroded and missing steps.

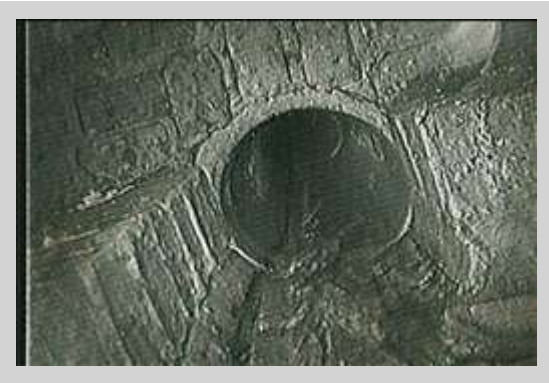
8 in. Circular Gravity Sewer Pipe Out @ 12 O'Clock

Barrel deterioration and infiltration. Channel deterioration.

Infiltration: **None** Pipe Seal Cond: **Cracked**
